Manhole Inspection Summary

Manhole # S47I2_021MH

Insp Date: 11/11/08 4:25 PM

Location Address: **4624 Curtis Ave**

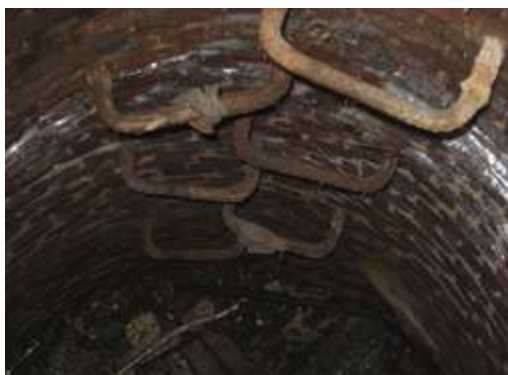
Steps Count: **6** Missing: **0** ☒ **Corroded**

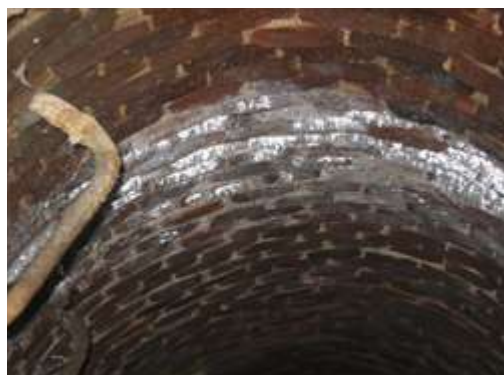
Defect 2

Infiltration: ☐ None ☒ **Joint** ☐ Cracks ☐ Mortar ☐ Roots ☒ **Wall**

Infiltration

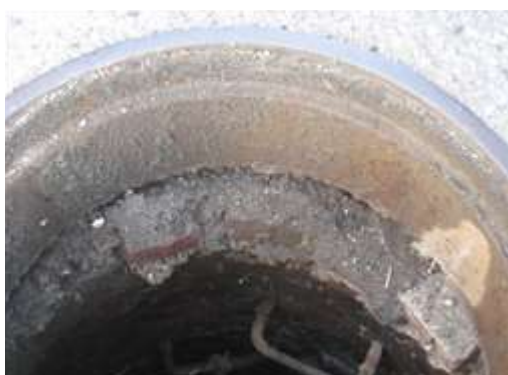
Defect 1

Condition: ☐ Sound ☐ Cracked ☐ Root Intrusion ☐ Loose Brick ☒ **Deteriorated**

Frame-Chimney Joint

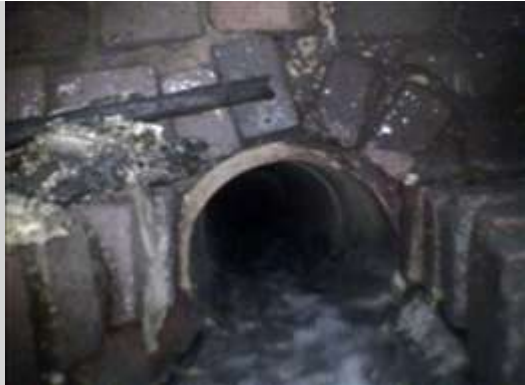
12 O'Clock Outflow

8 in. Circular Gravity Sewer
Pipe Out @ 12 O'Clock

Pipe Height: **8.4** (in.) Rod and Bar (Angled)
Pipe Material: **Unknown** ☐ Pipe Lined
Invert Depth: **12.00** (ft.) Flow Characteristics: **Fast**
Deposits: ☒ None ☐ Mud ☐ Sludge ☐ Debris ☐ Grease
Silt Depth: (in.) Deposits Extent:
Infiltration: **None** Pipe Seal Cond: **Sound**

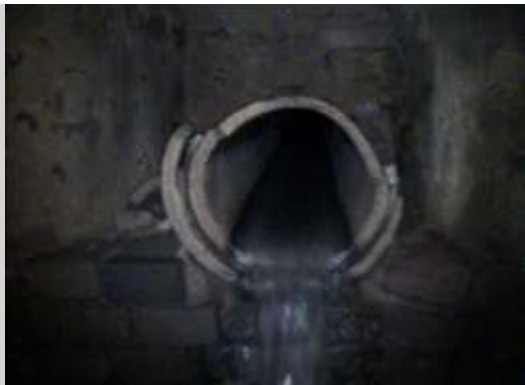
7 O'Clock Inflow

8 in. Circular Gravity Sewer
Pipe In @ 7 O'Clock

Pipe Height: **8.4** (in.) Rod and Bar (Angled)
Pipe Material: **Clay** ☐ Pipe Lined
Invert Depth: **9.70** (ft.) Flow Characteristics: **Fast**
Deposits: ☒ None ☐ Mud ☐ Sludge ☐ Debris ☐ Grease
Silt Depth: (in.) Deposits Extent:
Infiltration: **Evidence** Pipe Seal Cond: **Cracked**

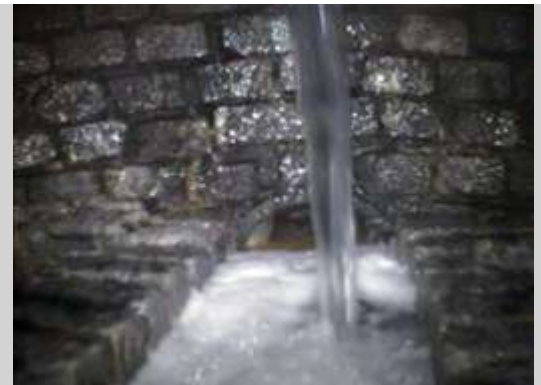
Drop In @ 7 O'Clock

Drop: **Outside** Rod and Bar
Angled: **Yes** Reading: **10.90** (ft.)
Inv Depth: **11.90** (ft.)
Drop Condition: **Open**
